# **DOWNTOWN LIGHTING STUDY – PHASE ONE FY25**

# PROJECT BACKGROUND AND GOALS

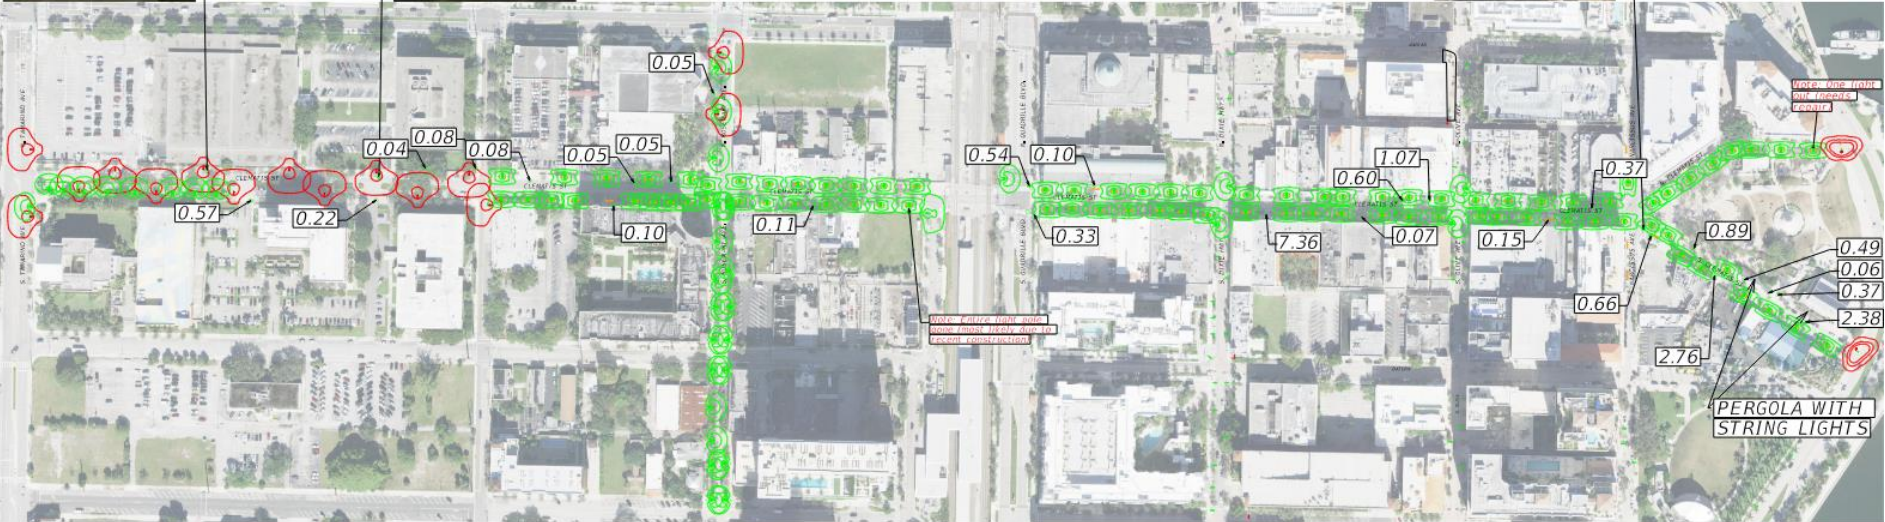
Calculation Summary		
Label	Avg	Avg/Min
Clematis Sidewalk 6	2.28	5.70
Clematis Sidewalk 7	2.48	12.40
Clematis Sidewalk 8	2.20	11.00

BRIGHT LIGHT  
ACROSS STREET

ENTIRE  
SIDEWALK  
COVERED  
BY TREES

LARGE TREE  
BLOCKING LIGHT

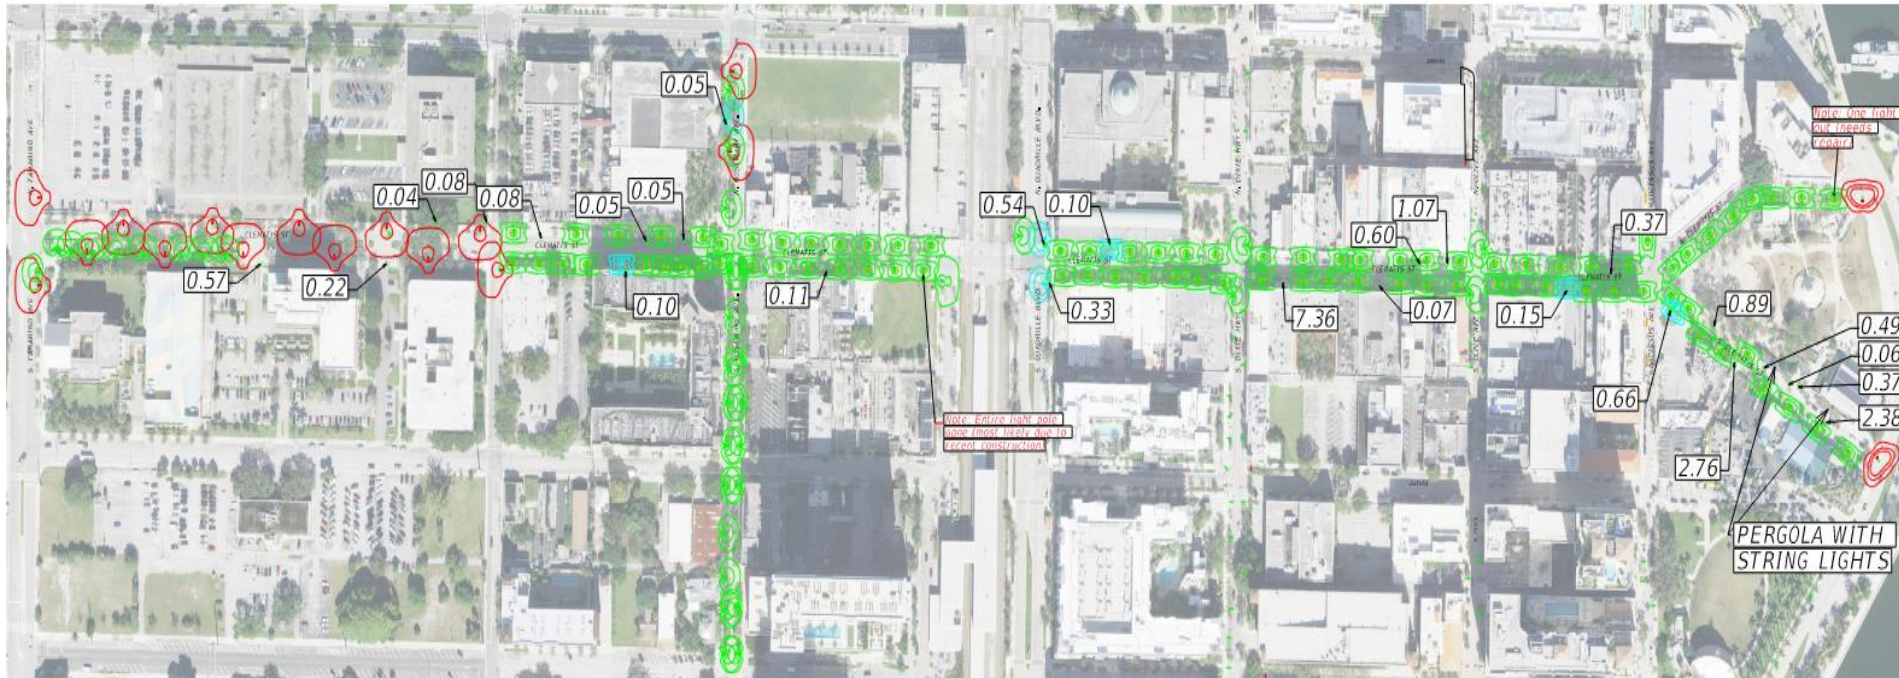
Calculation Summary		
Label	Avg	Avg/Min
Clematis Sidewalk 6	2.28	5.70
Clematis Sidewalk 7	2.53	4.22
Clematis Sidewalk 8	2.64	3.30
