# **DOWNTOWN LIGHTING STUDY – PHASE ONE FY25**

# PROJECT BACKGROUND AND GOALS

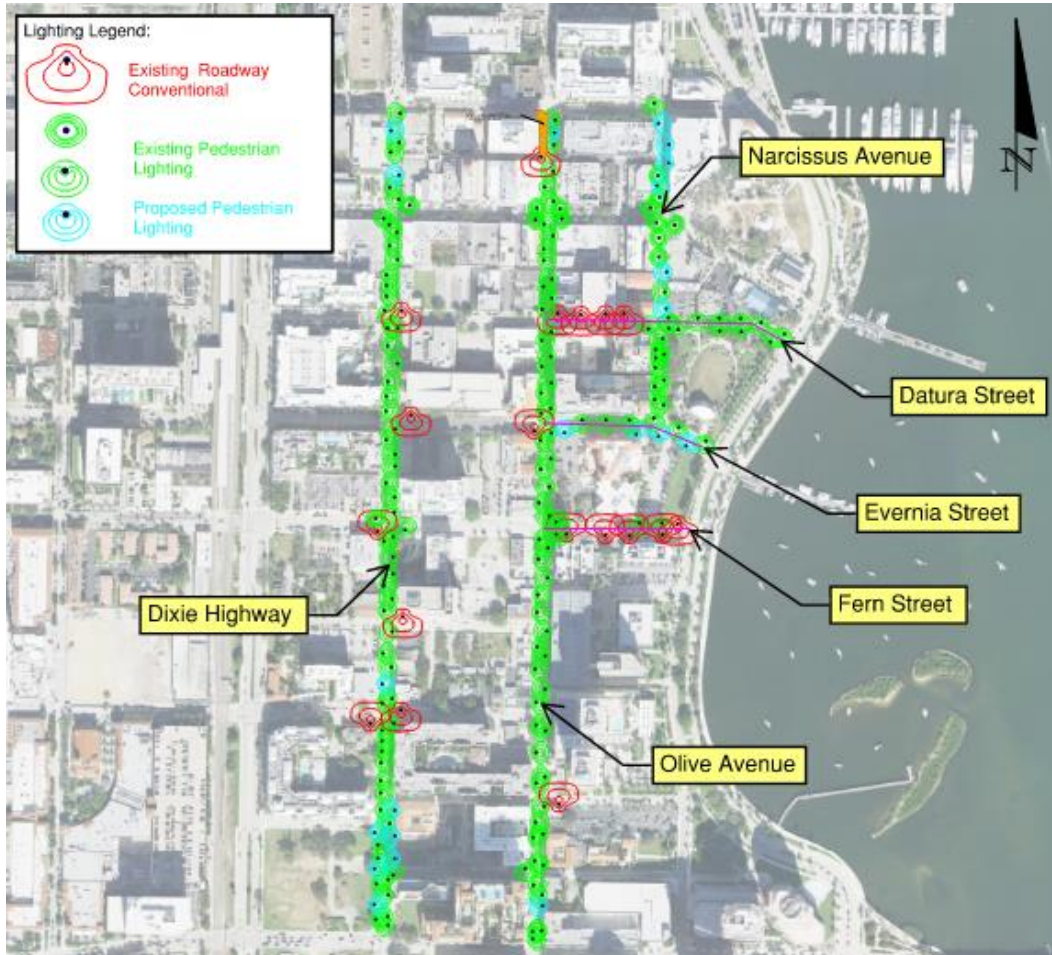
## Existing Lighting Layout

Calculation Summary		
Label	Avg	Avg/Min
Datura Sidewalk 1	1.60	2.00
Datura Sidewalk 2	1.34	4.47
Datura Sidewalk 3	0.96	4.80
Datura Sidewalk 4	1.16	5.80
Dixie Hwy Sidewalk 1	2.17	2.71
Dixie Hwy Sidewalk 10	1.51	3.02
Dixie Hwy Sidewalk 11	1.30	2.17
Dixie Hwy Sidewalk 12	1.23	4.10
Dixie Hwy Sidewalk 13	1.70	5.67
Dixie Hwy Sidewalk 14	1.22	12.20
Dixie Hwy Sidewalk 15	1.78	17.80
Dixie Hwy Sidewalk 2	1.25	6.25
Dixie Hwy Sidewalk 3	0.87	4.35
Dixie Hwy Sidewalk 4	1.30	2.60
Dixie Hwy Sidewalk 5	1.35	3.38
Dixie Hwy Sidewalk 6	1.29	12.90
Dixie Hwy Sidewalk 7	1.10	5.50
Dixie Hwy Sidewalk 8	1.27	4.23
Dixie Hwy Sidewalk 9	1.56	3.12
Evernia Sidewalk 1	0.91	9.10
Evernia Sidewalk 2	0.37	3.70
Fern Sidewalk 1	2.41	2.41
Fern Sidewalk 2	1.58	3.95
Narcissus Ave Sidewalk 1	2.05	5.13
Narcissus Ave Sidewalk 2	1.94	3.23
Narcissus Ave Sidewalk 3	0.68	6.80
Narcissus Ave Sidewalk 4	3.74	37.40
Narcissus Ave Sidewalk 5	0.16	N.A.
Narcissus Ave Sidewalk 6	1.94	N.A.

S Olive Sidewalk 1	1.15	11.50
S Olive Sidewalk 10	1.94	2.16
S Olive Sidewalk 11	1.58	5.27
S Olive Sidewalk 12	2.19	2.74
S Olive Sidewalk 2	1.56	15.60
S Olive Sidewalk 3	1.56	3.90
S Olive Sidewalk 4	1.34	6.70
S Olive Sidewalk 5	1.35	4.50
S Olive Sidewalk 6	1.16	5.80
S Olive Sidewalk 7	1.64	4.10
S Olive Sidewalk 8	1.75	2.50
S Olive Sidewalk 9	1.68	4.20

## Design Lighting Layout

Calculation Summary		
Label	Avg	Avg/Min
Datura Sidewalk 1	1.61	2.01
Datura Sidewalk 2	1.38	3.45
Datura Sidewalk 3	1.13	3.77
Datura Sidewalk 4	1.31	3.28
Dixie Hwy Sidewalk 1	2.17	2.17
Dixie Hwy Sidewalk 10	1.64	2.73
Dixie Hwy Sidewalk 11	1.52	2.17
Dixie Hwy Sidewalk 12	1.40	2.00
Dixie Hwy Sidewalk 13	1.79	3.58
Dixie Hwy Sidewalk 14	1.44	2.40
Dixie Hwy Sidewalk 15	1.92	3.84
Dixie Hwy Sidewalk 2	2.39	3.98
Dixie Hwy Sidewalk 3	2.44	3.49
Dixie Hwy Sidewalk 4	1.63	2.33
Dixie Hwy Sidewalk 5	1.81	3.62
Dixie Hwy Sidewalk 6	1.73	3.46
Dixie Hwy Sidewalk 7	1.68	2.40
Dixie Hwy Sidewalk 8	1.50	3.75
Dixie Hwy Sidewalk 9	1.63	2.72
Evernia Sidewalk 1	1.15	3.83
Evernia Sidewalk 2	1.20	4.00
Fern Sidewalk 1	2.42	2.42
Fern Sidewalk 2	1.59	3.98
Narcissus Ave Sidewalk 1	2.00	4.00
Narcissus Ave Sidewalk 2	2.01	2.23
Narcissus Ave Sidewalk 3	1.49	3.73
Narcissus Ave Sidewalk 4	4.32	6.17
Narcissus Ave Sidewalk 5	1.51	2.52
Narcissus Ave Sidewalk 6	2.78	9.27

S Olive Sidewalk 1	1.52	5.07
S Olive Sidewalk 10	2.06	2.06
S Olive Sidewalk 11	1.62	3.24
S Olive Sidewalk 12	2.22	2.78
S Olive Sidewalk 13	1.43	2.38
S Olive Sidewalk 14	1.87	3.12
S Olive Sidewalk 2	1.80	4.50
S Olive Sidewalk 3	1.64	3.28
S Olive Sidewalk 4	1.58	3.16
S Olive Sidewalk 5	1.40	3.50
S Olive Sidewalk 6	1.36	3.40
S Olive Sidewalk 7	1.56	3.12
S Olive Sidewalk 8	1.75	2.50
S Olive Sidewalk 9	1.75	2.50
